# TEST REPORT

No. : SHIN2512003219CM01\_EN

Sample Name : PS Wall Panel

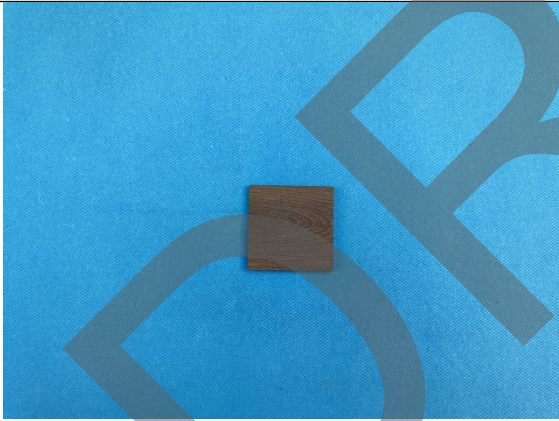
| Front View | Back View |
